Read Contaminated Codes

This flyer demonstrates DolphiScan's LOCUS Ultrasound Reader on a contaminated Data Matrix. The image shown below (to the right) is generated using the LOCUS Ultrasound Reader with the SoundVision decode software.

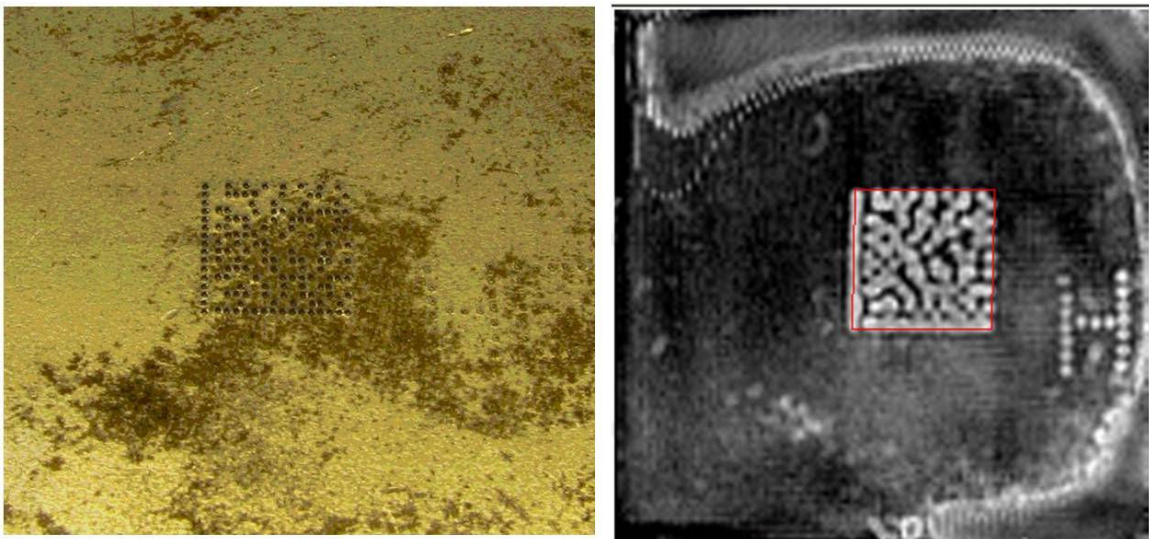
The DMx is marked on a steel plate and has been contaminated by rust.

Contaminated DMx on a steel plate

- DMx size: 16x16
- Cell size: 0.5 mm / 0.020 inches
- Marking method: Dot Peen
- DMx Issue: Contaminated by rust
